## FIELD INSPECTION REPORT

<b>Project Name:</b>	Mountain Valley Pipeline	<b>Inspector:</b>	Matthew Grant
<b>Inspection Date:</b>	Thursday, October 29, 2020	<b>Project Contact:</b>	Brian Clauto
<b>Spread H: Montgomery</b>	MP 230.6-230.8 ATWS 703, 704A, 1375, 1446 AR MN 274	<b>Weather:</b>	Rainy

## FIELD INSPECTION PHOTO LOG

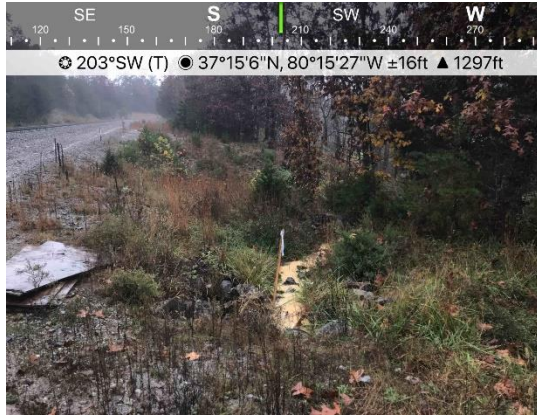
- Comments: Inspected the following resources: S-C21, S-001
- ECD's were in place and functioning at the designated crossings.
- During the inspection, the railway ditch was releasing turbid water at the juncture of designated stream S-001 and S-C21.

- Figure 1: Off AR MN274 at the railway ditch crossing, turbid water was being released into S-C21.

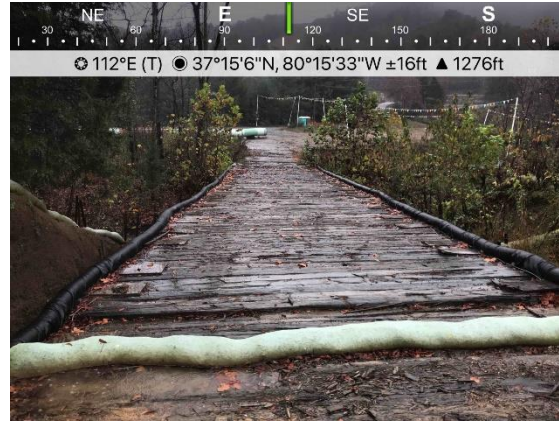
- Figure 2: At designated crossing S-C21, ECD's were in place.

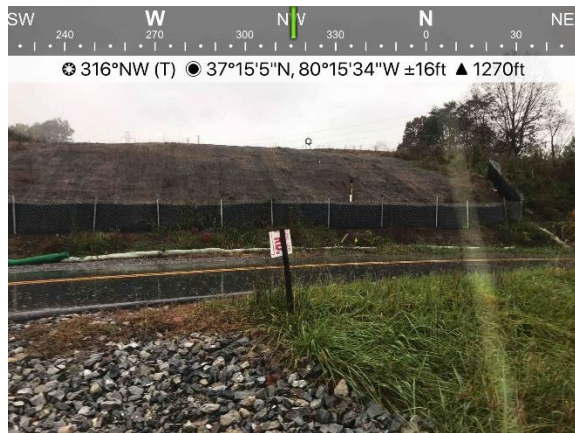
- Figure 3: At ROW crossing at Bradshaw Road all ECD's are in place.

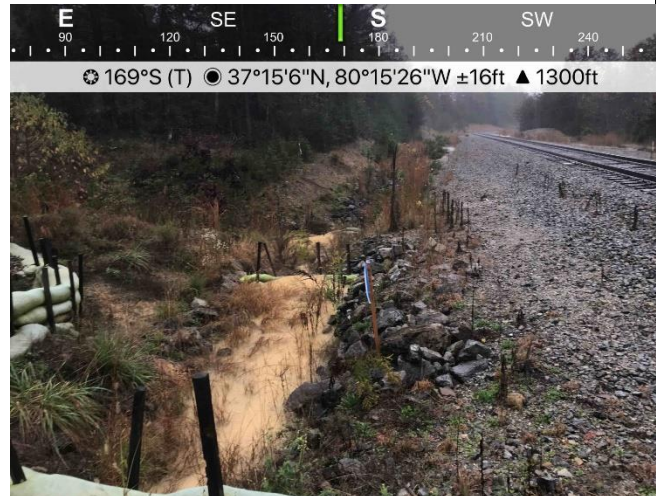
- Figure 4: Near the railroad ditch and confluence of S-001, ECD's were in place.
